ATLANTIC COAST BASIN
UNION BRANCH TOMS RIVER
OCEAN COUNTY
NEW JERSEY

PINE LAKE PARK DAM

NJ 00091

PHASE 1 INSPECTION REPORT
NATIONAL DAM SAFETY PROGRAM

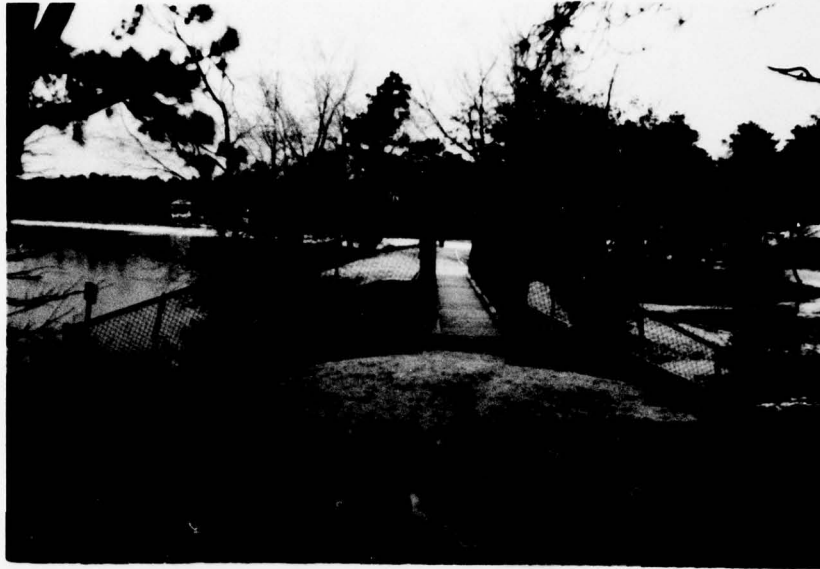
PHOTO 1

The timber portion of the walkway over the spillway was in good condition and structurally sound. The chain link fences forming its railings were in fair condition, needing minor repair. The chain link fences adjacent to the wingwalls also were in need of minor repair.

WALKWAY OVER SPILLWAY.
TOP OR CREST OF DAM.

1. Repairs to the walkway, which had been initiated at the time of visual inspection, should be completed.
2. The chain link fences adjacent to the spillway wing walls should be straightened where needed and any damaged sections replaced.
3. Vegetation on the dam embankment should be removed. Trees and brush should be cut at the ground surface in a way that will cause minimal disturbance to the embankment.
4. The eroded areas on the dam embankment should be properly filled and compacted. Such work should be done immediately after the vegetation has been removed.

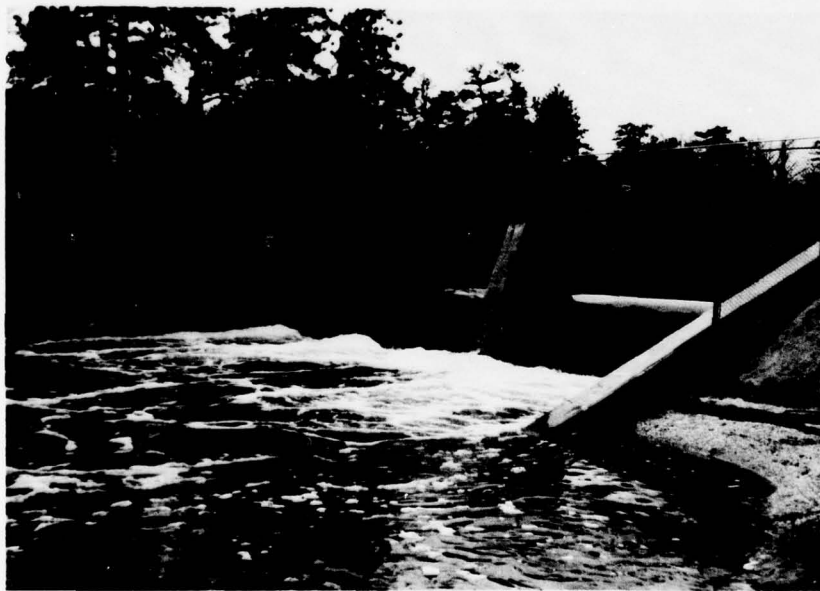
PHOTO 2

The crest of the spillway appeared uniformly aligned although it was completely submerged at the time of inspection. The center pier which supports the pedestrian bridge or walkway was in fair condition with spalling and erosion at the water line. However, it appeared to be structurally sound. Spalled areas were noted on all wingwalls especially at the water line. Also, adjacent sections of the wingwalls were misaligned at construction joints in two places: 1. downstream south wingwall - vertical misalignment of 1 to 2 inches and 2. downstream, north wingwall - horizontal misalignment of 1 inch. The vertical construction joint in the downstream, south wingwall was open approximately 2 inches and partially filled with mortar.

SPILLWAY.

5. Riprap should be installed and longitudinally centered at the normal water line on the upstream face of the dam along the entire length of the embankment.
6. The concrete spillway should be thoroughly inspected and repaired as outlined below:
 - a. Drain the lake to an elevation equal to the inverts of the sluices.
 - b. Sand blast all concrete and apply an epoxy preservative coating to all surfaces.
 - c. Pressure grout all major cracks and patch all spalls and eroded surfaces.

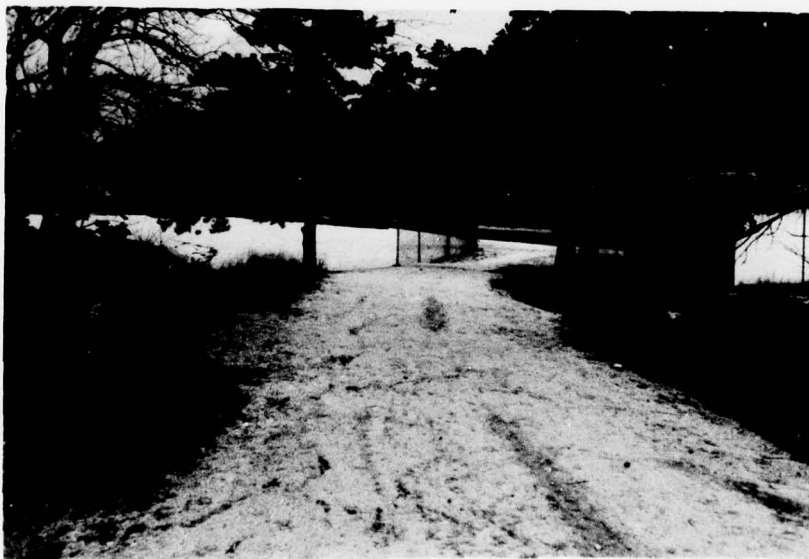
PHOTO 4

There was no evidence at the time of inspection of overtopping of the dam. The beach was in good condition and its crest was found to be 2.2 feet below the level of the top of dam and 3.7 feet above the crest of the spillway. This is close to the conditions assumed in the 1941 calculations. It is our opinion that in the event of a 100-year storm, the present beach, in conjunction with the spillway, would perform essentially the same as intended in 1941.

CREST OF DAM AND EROSION ON UPSTREAM FACE, BEACH
NORTH OF DAM (EMERGENCY SPILLWAY).

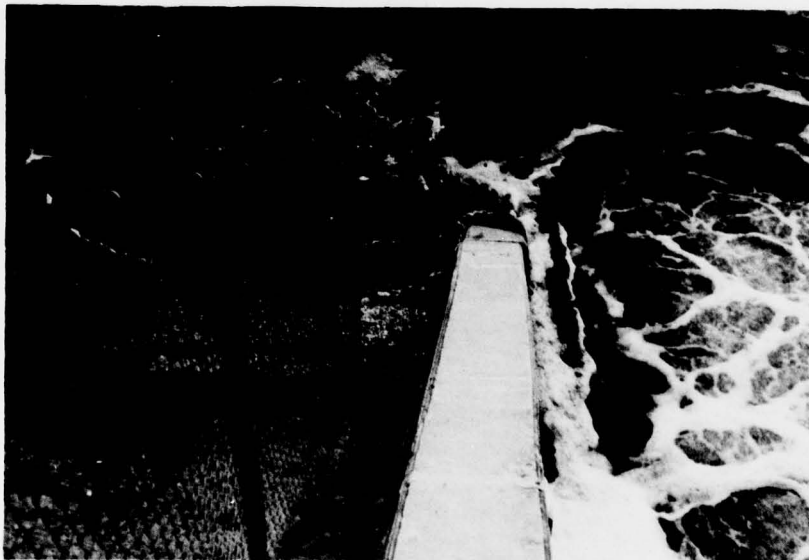
PHOTO 6

The misalignment of the spillway wingwalls noted in paragraph 3.1.c. did not appear to indicate a serious structural deficiency in that component of the dam. It could not be determined which side of the construction joint shifted. Furthermore, past inspection reports indicate that a similar state of misalignment and widening of constructions joints has existed since 1946. Therefore, it appears that these conditions have not significantly advanced during the past 30 years or more.

HORIZONTAL DISPLACEMENT AT CONSTRUCTION JOINT AND
REPAIRS ON NORTH-UPSTREAM WINGWALL.

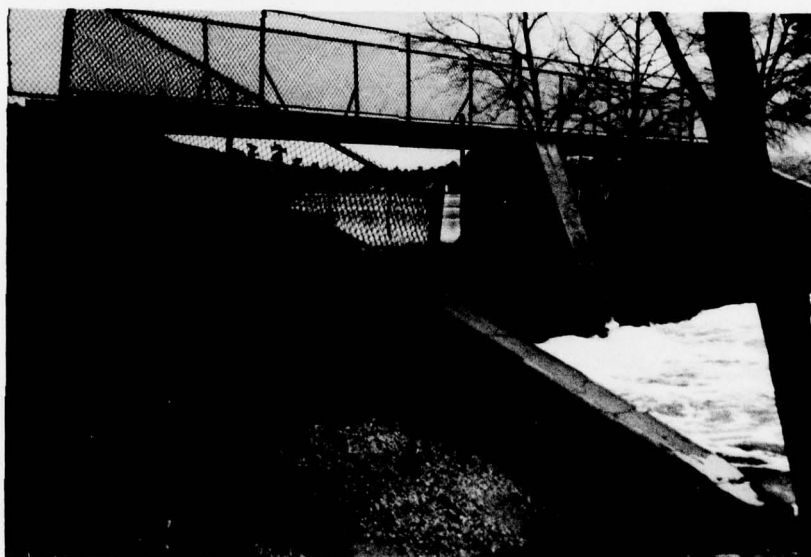
PHOTO 8

SPALL ON PIER. CRACKS AND SPALL ON SOUTH-
DOWNSTREAM WINGWALL. EROSION AT WINGWALL.

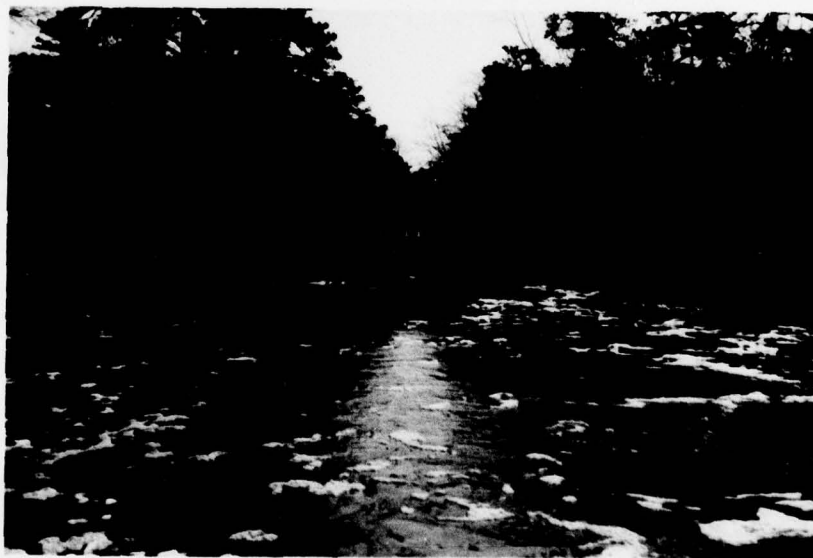
PHOTO 10

VIEW LOOKING DOWNSTREAM. ROAD BRIDGE
OVER STREAM.
